Manhole Inspection Summary

Manhole # S23WW1004MH

Insp Date: **5/2/07 6:42 PM**

Location Address: **DEEPDENE RD**

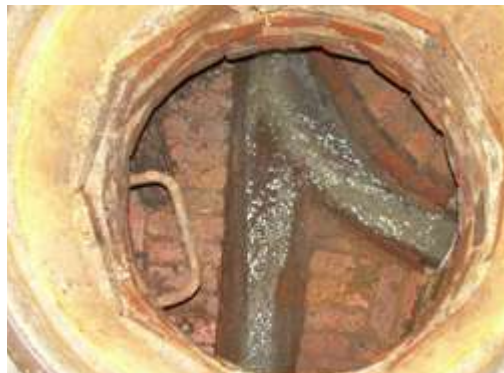
Top View

Frame leaks. Adjustment deterioration and infiltration. Corroded steps. Bench debris.

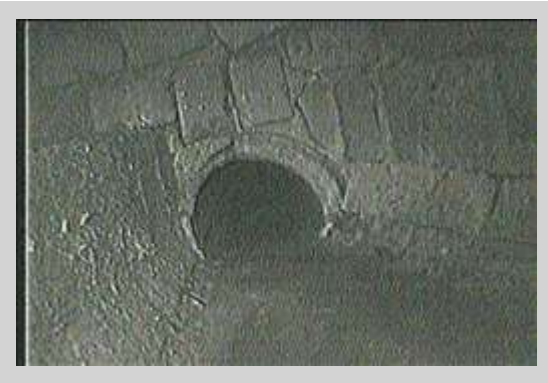
6 in. Circular Gravity Sewer Pipe Out @ 12 O'Clock

Barrel deterioration and infiltration.

Infiltration: **Evidence** Pipe Seal Cond: **Cracked**

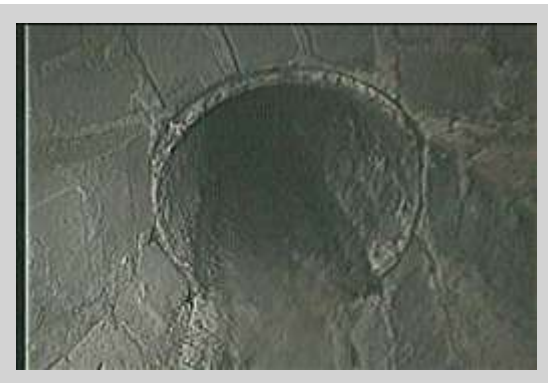
10 in. Circular Gravity Sewer Pipe In @ 5 O'Clock

Infiltration: **Evidence** Pipe Seal Cond: **Cracked**

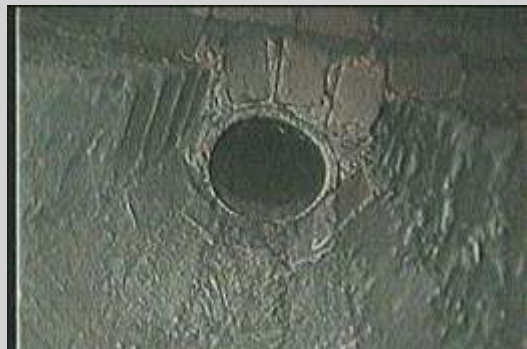
Pipe In @ 6 O'Clock

Barrel deterioration and infiltration. Channel deterioration.

Infiltration: **Evidence**

Pipe Seal Cond: **Cracked**
